## **EXPERIMENTAL INVESTIGATION OF CRACKED END-NOTCHED GLULAM BEAMS REPAIRED WITH GFRP BARS**

MARIJA TODOROVIĆ, IVAN GLIŠOVIĆ, BOŠKO STEVANOVIĆ  
UNIVERSITY OF BELGRADE, FACULTY OF CIVIL ENGINEERING  
BELGRADE, SERBIA

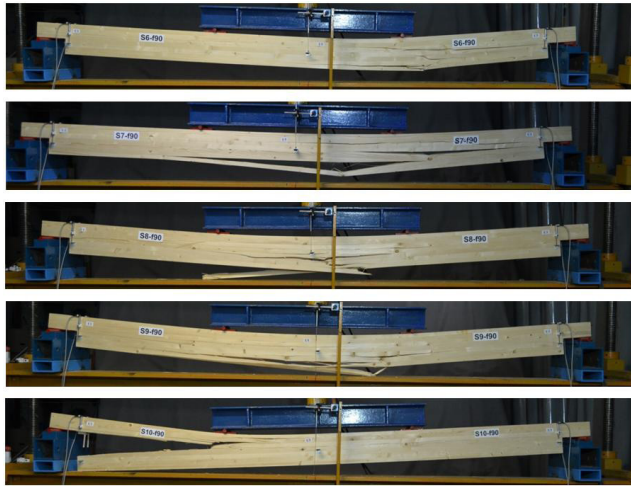
Fig. 6: Failure of repaired beams – series S-f90.

As previously mentioned cracked beams from series U were repaired with GFRP bars and tested again (series S-f90). Repaired notched beams experienced behaviour that is much more ductile when compared to original notched beams. Fig. 6 shows all five repaired beams after they had failed.

Four out of five repaired beams exhibited bending failure brought about by excessive tensile stresses in bottom laminations. This failure was generally initiated at defects or discontinuities (e.g. knots), which were located in the zone of maximum bending moment between load application points (Fig. 7a). The GFRP bars helped the cracked beams in resisting the horizontal shear force and prevented the possible shear failure. It was observed that despite the application of reinforcement, initial cracking occurred at relatively low loads within the notch detail that did not fail originally. This can be explained by the very small deformation capacity of wood before the tensile strength perpendicular to grain is exceeded. With further load increase, the crack growth was stable until failure in bending. The reinforcement showed sufficient strength for preventing excessive crack opening and lower beam part falling off.

One of the repaired beams failed due to unstable crack growth from the notch corner (Fig. 7b). It can be assumed that shear failure was a dominant failure mechanism (Mode II fracture). The failure happened on the same side as it did for the original unstrengthened beam. Failure of the notch was accompanied by bars withdrawal. No failure of the reinforcement itself was observed.

The reinforcement selected for the repair of cracked beams was GFRP bars with a diameter of 10 mm and length equal to the beams height of 220 mm, produced by manufacturer “Kompozit Armatura” from Kragujevac. Two bars were installed perpendicular to beam axis near the both notched ends of the cracked beams. The reinforcement was positioned as close as possible to the notch corners, while satisfying the requirements for minimal edge distances and spacing. Both sides were repaired, even though beams cracked only on one side, in order to achieve failure in bending and avoid fracture caused by crack opening on the opposite side of the existing crack.

When considering the specimens that were going to be repaired, special attention was put into inserting the GFRP bars. Clamps were used to pull together separated parts of the beams, after which the holes for bars were drilled very carefully to a diameter of 14 mm, with a drilling length of 220 mm, throughout the beams height. The dust from drilling was removed by air blowing. Firstly, the epoxy based SikaDur 30 adhesive was poured into the prepared holes. After that, bars were carefully inserted by twisting, so that the excess glue was squeezed out. Before the tests were performed, the beams were conditioned at a temperature of  $T = 20 \pm 2^\circ\text{C}$  and a relative humidity of  $\text{RH} = 65 \pm 5\%$  for seven days, in order for adhesive to achieve its full strength.
