EVALUATION OF GLULAM BEAMS' PERFORMANCE IN SPECIAL ENVIRONMENTAL CONDITIONS

ANTAL KÁNNÁR
UNIVERSITY OF WEST HUNGARY, INSTITUTE OF APPLIED MECHANICS
AND STRUCTURES
SOPRON, HUNGARY

ABSTRACT

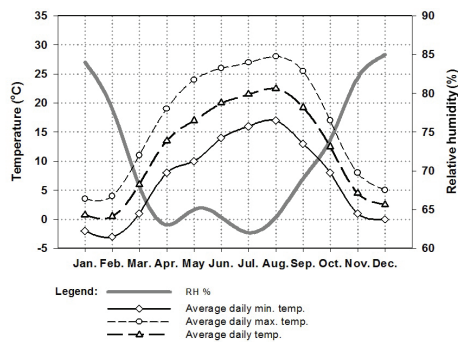
Fig. 1: Yearly average temperature and relative humidity in the Central European region. Source: National Weather Service of Hungary.

The survey included visual inspections four times a year. Fig. 1 provides information about the yearly average climate condition in the region. During the spring, summer, fall and winter seasons, the indoor temperature, dew point and relative humidity were recorded using a Volt craft DL-120T.H type data logger. Fig. 2a and b show partial recordings of an indoor pool's climate conditions.

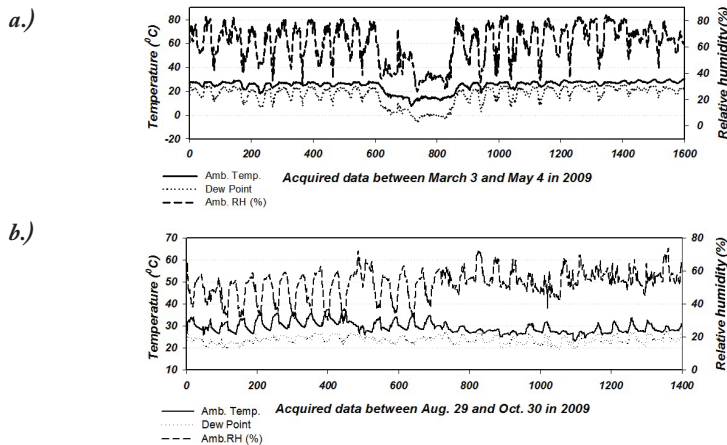
Fig. 2: Typical spring and fall recordings of T , RH and dew point of indoor pools.

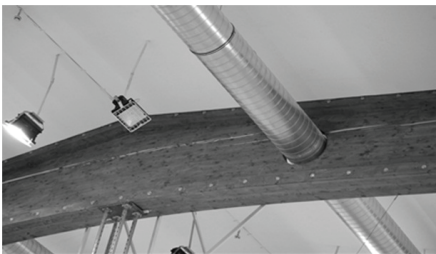
grained counterparts. Fig. 5 shows the likely failure of tapered beams due to the sloping grain occurrences (D –J1). Besides the sloping grain, the pith content is a significant factor for crack development. The weak parenchyma cells of the pith can trigger crack propagation during even slight ambient condition changes (Fig. 6). The ultrasonic measurement of the beams in

Fig. 5: The effect of sloping grain in tapered beam (unheated indoor environment).

The survey revealed another observation regarding tapered beams. Due to the manufacturing processes, tapered beams always contain lamellas with sloping grain. Such members are more prone to crack development because any cross grain elements is weaker than that of its straight

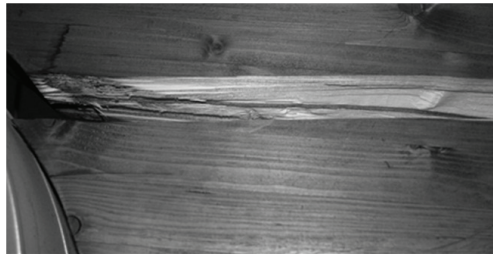
Fig. 6: Sever climate induced damage at the pit of the lamellas (unheated indoor environment).

Lamellas containing pith have higher rate of swelling-shrinkage properties and also show pure tension strength perpendicular to the grain, hence their application should be avoided.
