COMPREHENSIVE APPROACH TO ENSURE DURABILTY OF EXTERNAL WOODEN STRUCTURES

PETR KUKLÍK, ZDENĚK PROŠEK, ANNA GREGOROVÁ CZECH TECHNICAL UNIVERSITY IN PRAGUE CZECH REPUBLIC

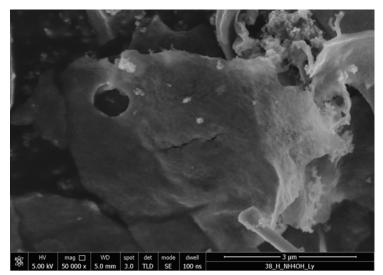
Fig. 1: Planar particle of amorphous TiO₂ (Photo: electron microscopy CTU, Prague).

After the application of TiO_2 , the planar morphology was proved by electron microscopy (Fig. 1). On the picture is possible to see that the surface of the particle is not plain but wavy and also it is not completely continuous. The holes cover 20% of the surface and aggregates cover 10%. Holes and aggregates in this amount have no negative impact on the UV absorption of the material as was proven by UV-VIS spectroscopy.

Material for chemical protection of wood by TiO_2 was chosen planar particles of TiO_2 because it is possible to prepare as photoactive (crystalline) and non-photoactive (amorphous) (Bahtat et al. 1992). We are expecting that the use of the planar particles of TiO_2 (Fig. 1) could be one of the method to ensure durability of wood and wooden structures during their planned service life. This will strengthen the confidence of users (e.g. engineers and architects) and boost the use of wood also in conventional fields of application like building structures etc. The goal of our work is study interaction between planar particles of TiO_2 and wood matter. In our study, we want to observe the direct interaction between wood tissue and particle of

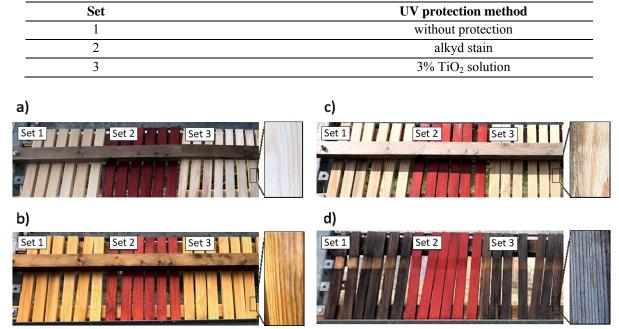
Fig. 2: Visual monitoring of the samples during exposure to the external environment: a) exposure time 0 days, b) exposure time 44 days, c) exposure time 83 days, d) exposure time 255 days.

Three sets of samples were used to describe the effect of wood protection using TiO_2 , which were exposed to the outside environment for 255 days. Each set contained six pine samples measuring 20 x 40 x 400 mm, which were placed external environment on the grounds of the University Centre of Energy Efficient Buildings. Tab. 1 shows the identification of individual samples with methods of protection. The samples were continuously visually monitored (Fig. 2) and subsequently, after 255 days, smaller samples were taken from the surface for microscopic sections.

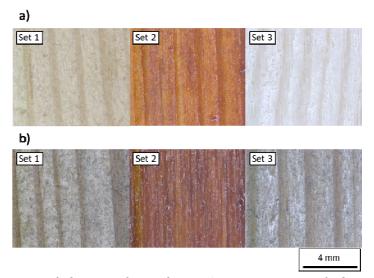
The surfaces of the tested samples can be seen in Fig. 3. The color of the wood surface can be seen with a protective coating for set of samples 2 and 3. Sample with a commercial protection (Set 2) shows no changes during exposure to the external environment. The surface of the sample without protection against UV degradation (Set 1) shows color changes which are caused degradation of wood by external environment. The color of wood changed from yellow (natural color) to brown for latewood and silver patina acquires on the surface of earlywood.

Fig. 3: Optical images of the sample surface: a) exposure time 0 days, b) exposure time 255 days, magnification 10x.

The differences between earlywood and latewood were caused by different bulk densities. The earlywood is more degraded than latewood due to its lower density and thus, a deeper light penetration into wood. A smaller color change effect can also be observed for a sample with TiO_2 protection (Set 3). These results are consistent with other studies dealing with UV degradation of wood (Cogulet et al. 2016). However, it must be noted that these findings were reached for the white spruce (*Picea glauca*) and samples were exposed in a QUV accelerated weathering tester from Q-Lab (USA) for 2000 h.

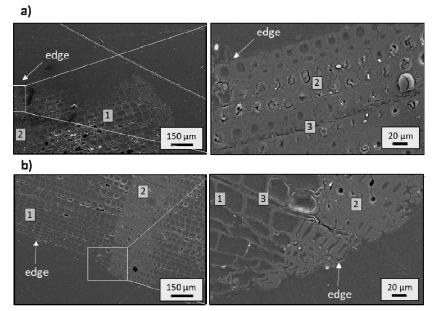
Change in the microstructure of sample without UV protection (Set 1) due to degradation by UV radiation can be seen (Fig. 4). The receding part of earlywood can be seen in the microstructure of the sample, which is more susceptible to UV degradation of wood. In addition, the loss of lignin by means of UV radiation thins the cell walls in the case of an earlywood cell and their impaired connection through the middle lamella, which is rich on lignin. The same effect of UV radiation is described in a study by Rowell (2005).

Fig. 4: SEM images of reference sample without a protective layer (Set 1), cross-section, magnification $250 \times$ and for cutout $1k \times$: (1) earlywood tracheid, (2) latewood tracheid, (3) parenchymal cell, a) exposure time 0 days, b) exposure time 255 days.

Electron microscopy images of the microstructure (Figs. 4-6) confirmed the results from optical microscopy. The microstructure is composed of 90% by volume of cells, which divide earlywood tracheids or latewood tracheids according to the period in which they grew (Prošek et al. 2015). The remaining microstructure is made up of parenchymal cells and resin channels.

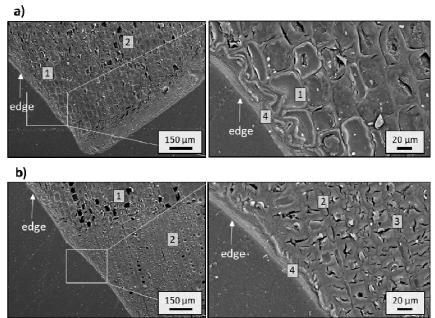
The UV protective coating can be seen in the microstructure (Fig. 5) of samples with commercial protective layer (Set 2). The protective layer is approximately 10 μ m thick. The microstructure does not show any significant changes in the cells due to the protective coating and thus UV radiation did not cause degradation of the material. Protective layer,

opaque pigmented coatings, act as very effective UV radiation screen. This is an effect that has been described in several studies (George et al. 2005).

Fig. 5: SEM images of sample with a commercial protective layer (Set 2), cross-section, magnification $250 \times$ and for cutout $1k \times$: (1) earlywood tracheid, (2) latewood tracheid, (3) parenchymal cell, (4) protective layer, a) exposure time 0 days, b) exposure time 255 days.

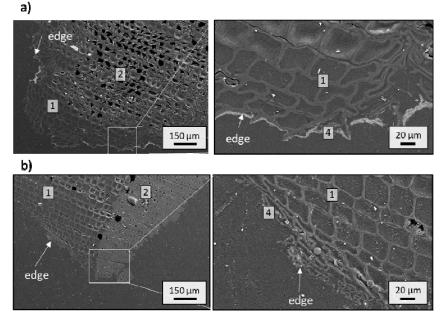
Sample with protection layer of TiO_2 (Set 3) can be seen on Fig. 6. Protection layer of TiO_2 has a thickness of approximately 5 μ m. The protective layer of TiO_2 is not visible in the microstructure after exposure to the external environment for 255 days and damaged wood cells of earlywood tracheid can be seen in the microstructure.

Fig. 6: SEM images of sample with TiO_2 protective layer (Set 3), cross-section, magnification $250 \times$ and for cutout $1k \times$: (1) earlywood tracheid, (2) latewood tracheid, (3) parenchymal cell, (4) protective layer, a) exposure time 0 days, b) exposure time 255 days.

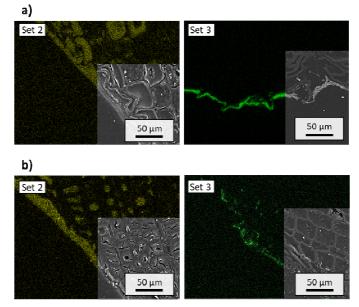
The element map determined by EDS can be seen in the Fig. 7. The commercial protective layer and the 3% aqueous TiO₂ solution layer were rich in iron and titanium, respectively. Therefore, these chemical elements were examined in the microstructure.

Fig. 7: Elemental microanalysis of samples with a protective layer – BSE detector magnified $lk \times$ with EDS element maps (yellow – iron, green – titanium), a) exposure time 0 days, b) exposure time 255 days.

The high iron (drier) content can be seen in the protective layer with a thickness of $10 \ \mu m$ for the sample with the commercial protective layer (Set 2). In addition, a high content of iron in the cell cavities of the so-called lumen can also be seen, which indicates that the wood is impregnated to a depth of 100 μm and thus reliably protected the wood cells. The depth of impregnation of 100 μm was also confirmed in the work of Rijckaer et al. (2001) who tested Scots pine sapwood in this way.

Samples with a protective TiO₂ layer (Set 3) show a high titanium content in the layer with a width of approximately 5 μ m. Furthermore, there is no titanium in the lumen and in the entire microstructure, which means that the wood has not been impregnated. The TiO₂ protective layer is not integral after exposure of the sample to the external environment and this results in a partial degradation of the wood cells. This is the effect of a weak connection between the TiO₂ layer and the wood surface. An aqueous solution of TiO₂ was used because after evaporation of the water, the TiO₂ particles are bonding by Van der Waals forces (Hu et al. 2014). The Van der Waals forces have a low binding effect and, as a result, TiO₂ particles are gradually leached out of the sample surface by rain. This statement is in agreement with the knowledge about the weak connection of particles by Van der Waals forces (Santamarina 2003, Santos et al. 2020).
