## **EFFECT OF THE FABRIC REINFORCEMENT OF STRUCTURAL HOLES IN WOOD BASED PANELS**

### **ABSTRACT**

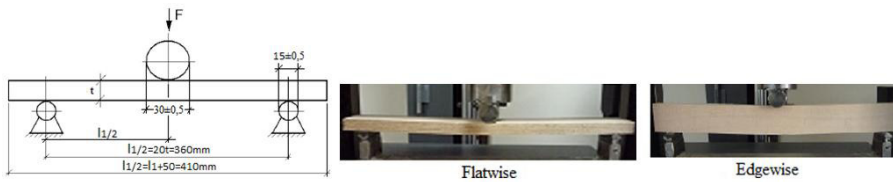
Fig. 2: Bending strength test setup.

The specific gravity (SG), and moisture content (MC), BS, and MOE of the samples were determined according to TS EN 323, TS EN 322, TS EN 310, and ASTM D 1037 standards, respectively. The samples were subjected to the 3 points bend testing in the flatwise and edgewise directions shown in Fig. 2. The samples were placed and were bent in the middle of the length (in the flat and edge position) on the Universal test machine Zwick Roel/Z200 at the Mechanical Laboratory of the Yalova University.
