THE IMPACT OF GEOMETRIC SHAPE OF THE LOG WALL CONSTRUCTION ELEMENTS ON THEIR FIRE BEHAVIOUR

LUDMILA TEREŇOVÁ, KATARÍNA DÚBRAVSKÁ, ANDREA MAJLINGOVÁ
TECHNICAL UNIVERSITY IN ZVOLEN, FACULTY OF WOOD SCIENCES AND TECHNOLOGY
DEPARTMENT OF FIRE PROTECTION
ZVOLEN, SLOVAK REPUBLIC

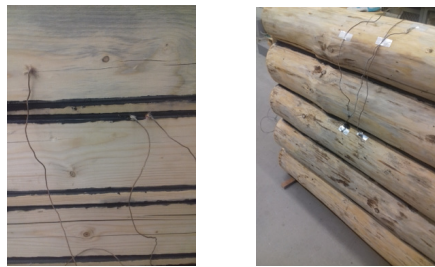
Twelve thermocouples were used to perform the experiment, which sensed the temperature of both the exposed and unexposed side of the test sample. Since six thermocouples were used for each log wall, three were applied on the exposed and three on unexposed side. The thermocouples were placed into the wood, in the depth of about 50 mm, and into the insulation made from the glass mineral wool, in the depth of 20 mm as well as into the layer of sealant, so that they did not lap over into the insulation in the groove. Position of the thermocouples is shown in Fig. 3.

Fig. 3: Position of thermocouples located on the samples.

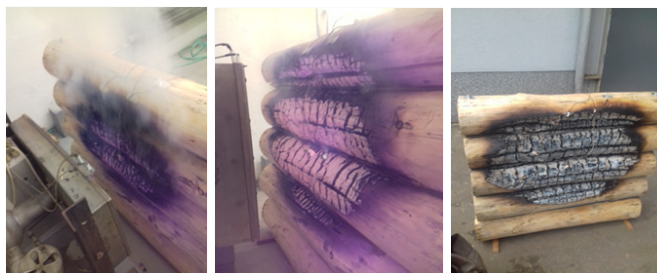
In Tab. 1, there are introduced the temperatures measured on individual thermocouples and in Fig. 7, there is introduced the round log wall during the testing (after 10 min, 30 min) and after the testing. Position of the individual thermocouples mentioned in Tab. 1:

Fig. 7: Testing the Sample 1 a) after 10 min, b) after 30 min, c) after the testing.

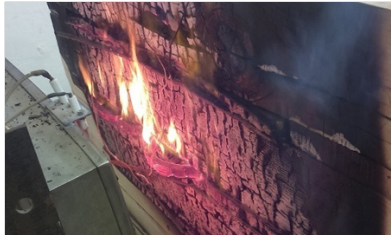
Fig. 9: Deformation of the protection rail before it is completely falling out.

At the beginning of the experiment with Sample 2, there was also observed a change in the colour of the surface of the wood from dark brown to black, spreading across the edge of the logs. The signs of cracking and charring began to appear a little earlier than in the case of a log wall made of round logs, i.e. after 2 min. At about half of the 3rd min, a spark was visible on the surface of the sample. After 11 min, the edge of the lower log was ignited on the exposed area of the wall (see Fig. 8 a), while the flame was spreading rapidly from the edge gradually over the entire area of the sample exposed area (see Fig. 8b). At the 15thmin, the flames began to recede and the smoke production intensity increased. At the 25thmin, the protection rail was destroyed as well as the sealant layers in the groove (Fig. 9).

At the 30th min, the protection rail completely fell out and there was an increase in the temperature in the insulation and subsequent accumulation of the combustion gases in the groove. At the 35th min, there was a flame extinguishing at the bottom of the wall. There occurred the sudden destruction of the lower log caused by a crack which grown due to the high temperature and the log was ripped along its entire length. From a safety point of view, therefore, the experiment was terminated prematurely at 36th min. But, we still expect that the structure should withstand the fire effects during the 45-min, despite the high temperature in the insulation layer of the groove at the 35th min of the test ($T_6 = 514^\circ\text{C}$).
