**INVESTIGATION OF THE MECHANISM OF FAILURE
BEHAVIOUR OF WOOD BASED MATERIALS USING
ACOUSTIC EMISSION ANALYSIS AND IMAGE
PROCESSING**

Tensile strength, modulus of elasticity under tension and failure behaviour were ascertained for particleboards, OSB, plywood and MDF with two raw density grades by means of acoustic emission analysis. The strain distribution over the sample surface under load was determined with video image correlation.

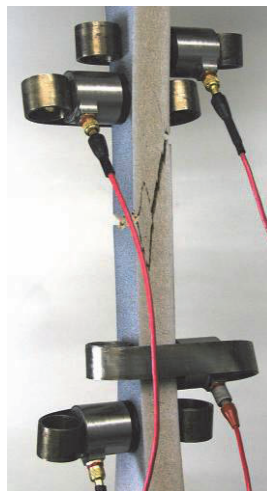
Fig. 4: Position of the 4 sensors for the acoustic emission analysis

For the acoustic emission measurements an AMS-3 equipment (*Vallen / Germany*) with 4 SE45-H sensors (*Dunegan Engineering Corp.*) was used. The sensors are mass-loaded and behave as displacement sensors below 45 kHz (high pass filtering of 30 kHz) and as velocity sensors above 70 kHz (low-pass filtering of 1'000 kHz). Four sensors were necessary for the acoustic location, 2 on each side (*Fig. 4*). The goal was to combine the signals of the acoustic emission analysis and of the on optical displacement measurement.

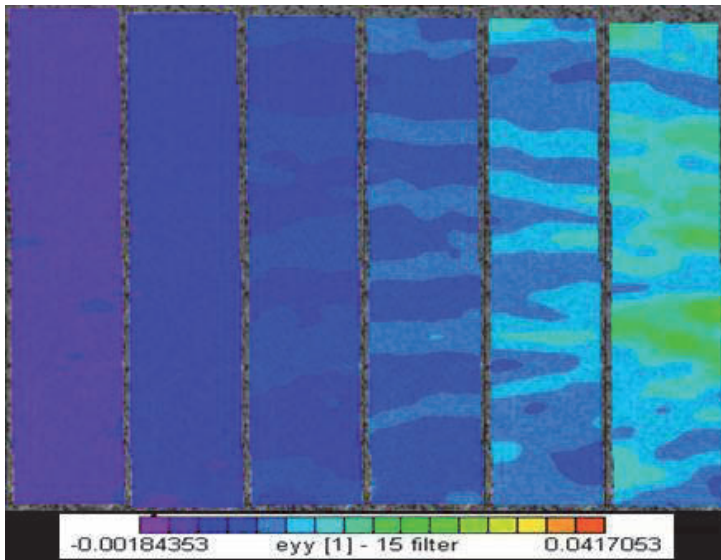
Fig. 5: Strain distribution of MDF 500 with 1%, 20%, 40%, 60%, 80% and 100% (from left to right) of the fracture load

Selected test specimens were used to determine the displacement under load on the surface of their narrow and broad side. Obvious differences between the tested materials could be observed. The deformation of MDF is very homogenous while OSB shows perspicuous strain peaks due to the considerably larger particles. These differences can easily be seen in Figs. 5 and 6. In Fig. 6 OSB shows elevated displacement (red) in the upper area of the sample.

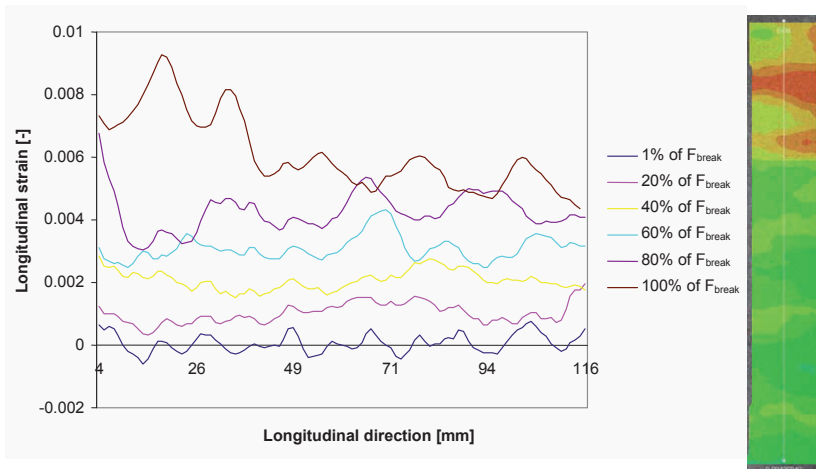
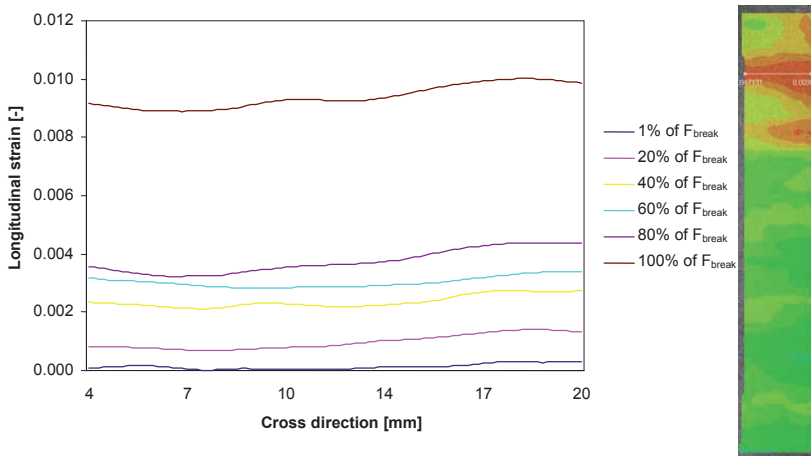
a: strain in longitudinal direction (within panel plane) with 1%, 20%, 40%, 60%, 80% and 100% of the fracture load

b: strain in transverse direction (perpendicular to the panel plane) with 1%, 20%, 40%, 60%, 80% and 100% of the fracture load

Fig.7: Strain of plywood examining the small surface

Fig. 7 shows the strain of plywood under load. The sudden rise of the strain under increasing load can be attributed to the rupture of a central ply lying perpendicular to the load direction.

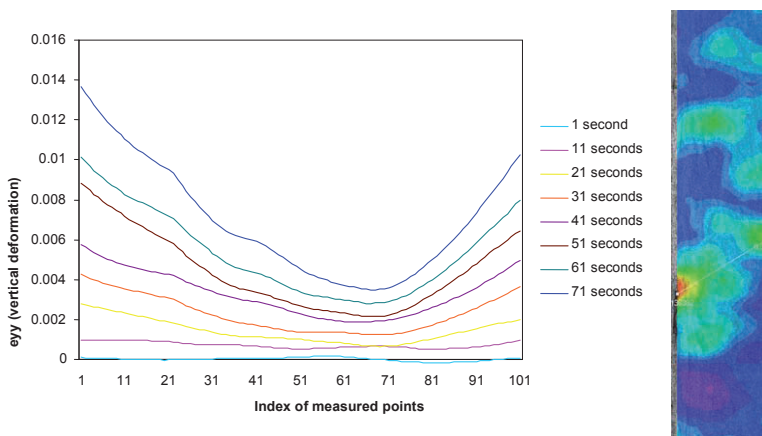
Fig. 8: Longitudinal strain of OSB_{||} along the crack after 1, 11, 21, 31, 41, 51, 61 and 71 seconds

Fig. 8 shows the strain along the crack (view on the narrow surface). Already at an early stage weak spots could be distinguished between the particles of the two face layers.

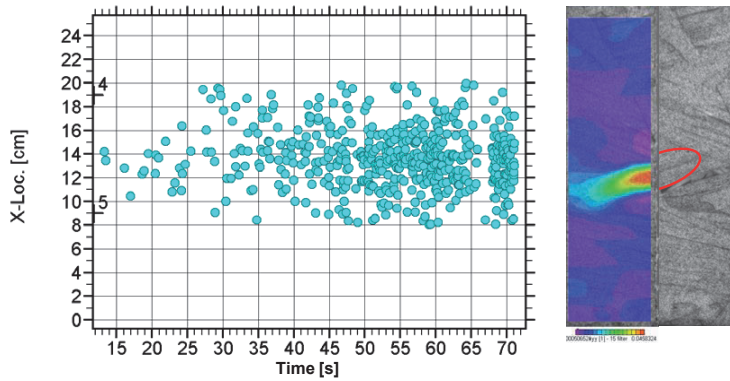
Fig. 13: Crack location of OSB_⊥ with SEA and VIC2D (longitudinal direction)

OSB shown in Fig. 13 behaves similarly to plywood. At the time of fracture of the OSB a considerable rise of the energy can be seen (Fig. 14). After the energy rise (53 seconds after the start of the load test) an obvious change of the displacement can be observed.

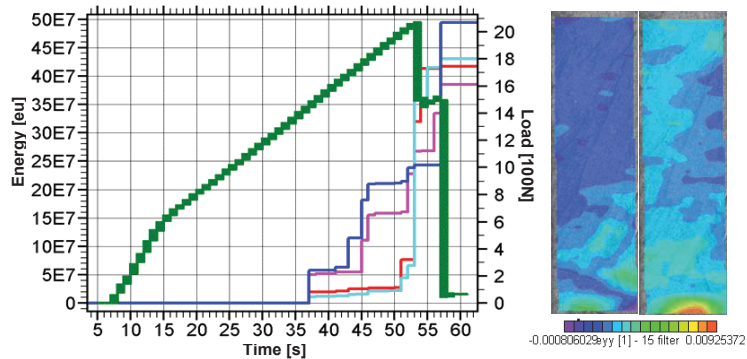
Fig. 14: Cumulative Energy as a function of time and strain distribution of OSB_{||} (broad specimen side). Before and after the energy rise occurring around 53 seconds into the test.

The two images showing the strain distribution (Fig. 14) were taken one second apart. 53 seconds into the test the rise in cumulative acoustic emission signal energy is clearly visible. Also, in the load-displacement diagram a certain load drop can be observed.
